State of Washington Department of Ecology
**Cruise Ship Memorandum of
Understanding, Cruise Operations in
Washington State Inspection Report**

Northwest Regional Office

PHOTO ADDENDUM – AMSTERDAM
HOLLAND AMERICA LINE
JULY 29, 2019

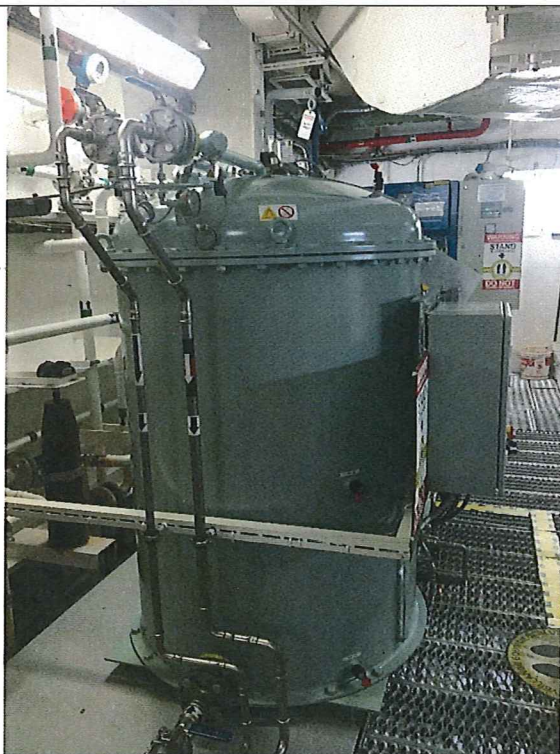
Dirty bilge water is first treated with a Westfalia centrifugal oily water separators (OWS) (photo #19) and is then sent to a static RWO OWS (photo #20) which treats to a level of less than 15 ppm. Prior to discharge, any OWS effluent goes through a white box (photo #21) to only allow discharges (photo #22) at less than 15 ppm oil content maximum. Any treated bilge that does not meet that level is sent by y-valve to the dirty bilge tank for re-processing. Discharges of treated oily bilge take place outside of MOU related waters. Staff confirmed that they were not aware of any rerouting of bilge to avoid proper treatment. All bilge equipment is labeled to prevent tampering and the area is monitored and video recorded. Any graywater that would overflow to the bilge, is treated as bilge. If blackwater were to overflow to bilge, it would also be treated as bilge and discharged per the more stringent of the two wastestreams. The oil record book (photo #06) was reviewed during the inspection.

Photo # 19 Image: IMG_0372 Date: 7/29/2019
 Taken by: Amy Jankowiak
 Description: Bilge – OWS - centrifugal

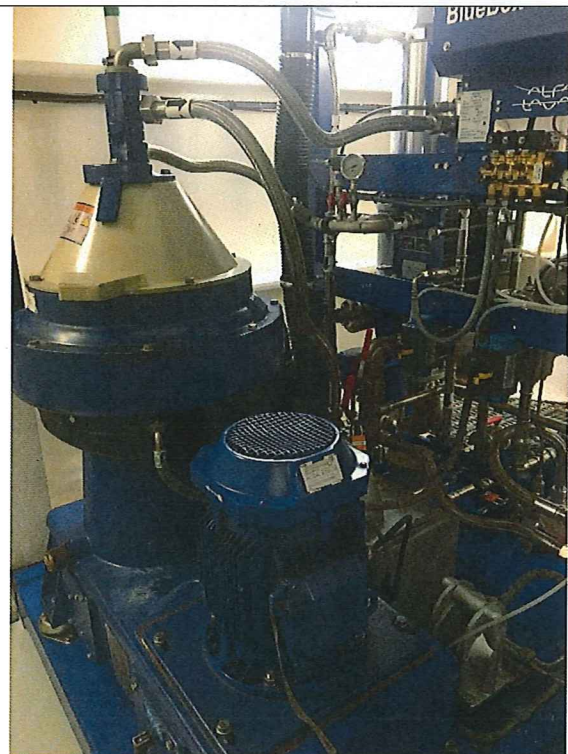
Photo # 20 Image: IMG_0373 Date: 7/29/2019
 Taken by: Amy Jankowiak
 Description: Bilge – OWS - static

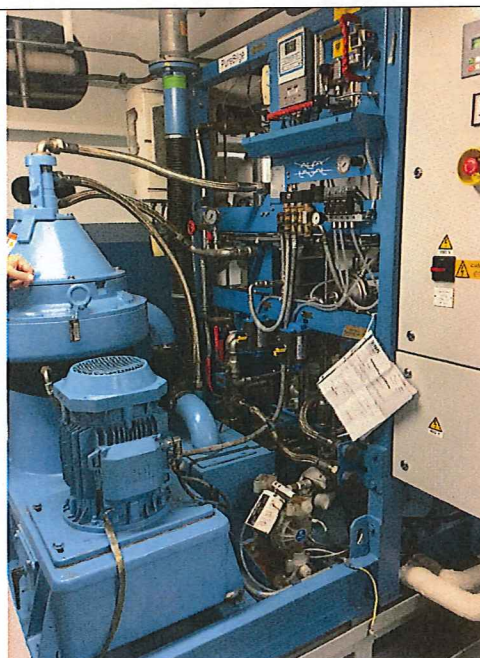
Oily bilge water is collected to the dirty bilge settling tank and is first treated with either a Marinfloc oily water separator system (OWS) (photo #07) or an Alfa Laval centrifugal OWS (photo #08). The oily bilge is treated to less than 15 parts per million (ppm) oil content. Prior to discharge, the clean bilge is sent through "white box" (photo #10) which can't be bypassed and doesn't allow discharges of greater than 15 ppm. The treated oily bilge water is then discharged outside of MOU related waters at a maximum of 15 ppm, but typically 3-7 ppm, and outside of MOU related waters. The overboard discharge was locked during the inspection (photo #09). The Chief Engineer has the one key to the white box, and discharges of clean bilge and offloads of oily sludge are recorded in the Oil record Book. No bypasses or re-routing around the OWS or white box has been known to occur. If there is any water other than bilge that combines with bilge water, it would be treated as bilge for treatment. The vessel also has the ability to pump out the bilge to shore-based collection.

Photo # 8 Image: IMG_2140 Date: 9/28/2019
 Taken by: Evan Dobrowski
 Description: Bilge – centrifugal Alfa Laval OWS

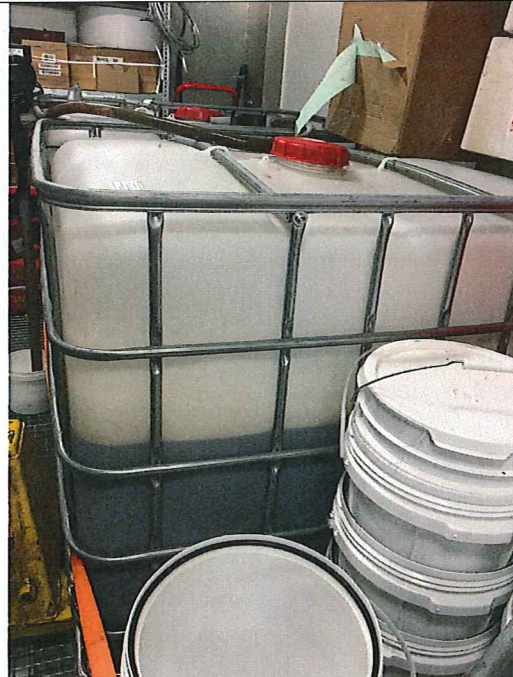
Photo waste (photo #24) goes through a silver recovery unit with offloads in Victoria when silver is less than 5 ppm. Tests are logged and kept. X-rays are done digitally without any waste. Fluorescent bulbs are crushed on board with a mercury vapor removal system (bulb crusher) (photo #23). Filters are offloaded as hazardous waste. Hazardous waste materials are stored separately and offloaded only in Victoria on this route. Solid waste (garbage, recyclables

Photo # 24 Image: IMG_0444 Date: 9/28/2019
Taken by: Amy Jankowiak
Description: GR – Hazardous Waste Stor – Photo Waste

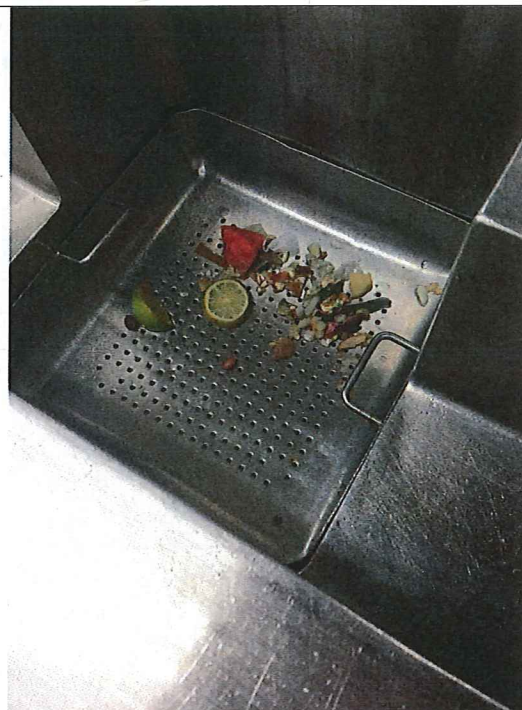
Photo # 26 Image: IMG_0446 Date: 9/28/2019
Taken by: Amy Jankowiak
Description: Galley – Pulper screen

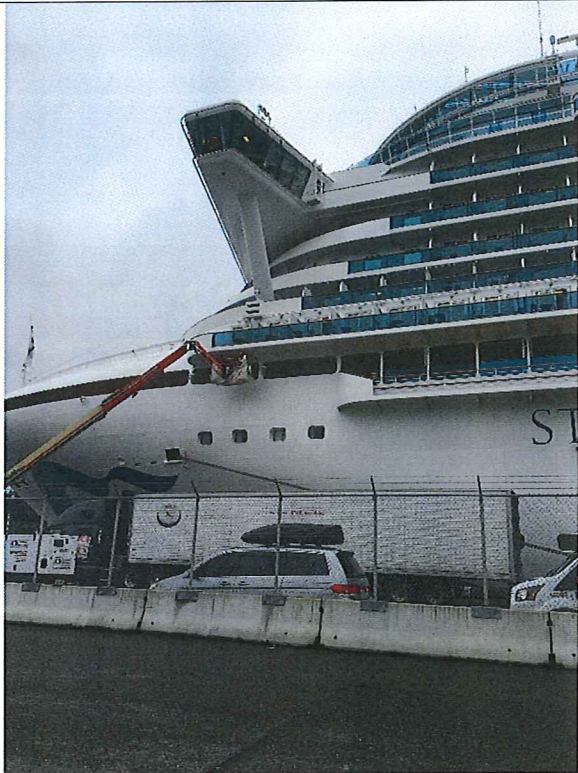
Photo # 2 Image: IMG_0388 Date: 9/8/2019
Taken by: Amy Jankowiak
Description: Paint touch up work

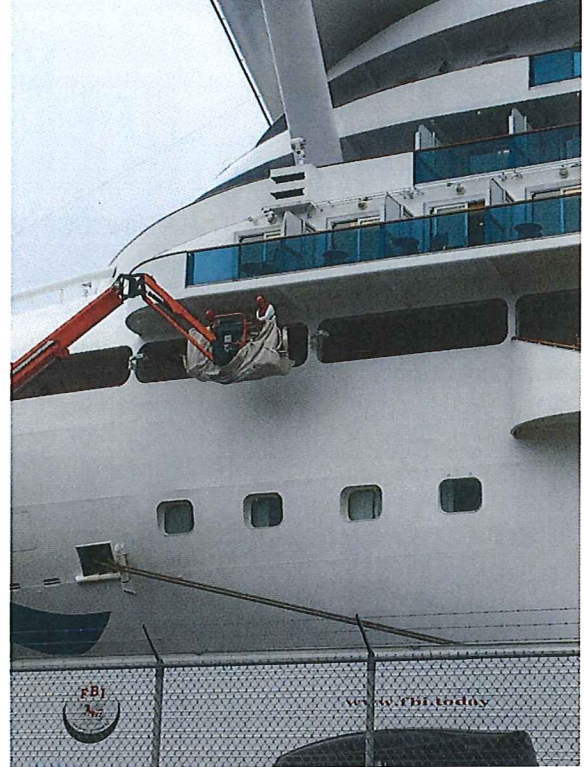
Deck wash is done with NPDES VGP allowed materials (non-toxic, phosphate free, biodegradable cleaners) and processes. Outside vessel maintenance such as paint chipping and painting follows a SOP with the Port of Seattle and Best Management Practices are used when conducting work. It is first cleared with agents and port approval. BMPs include secondary containment for paint and two staff per painting, one to assure paint is contained.

Photo # 3 Image: IMG_0390 Date: 9/8/2019
Taken by: Amy Jankowiak
Description: Paint touch up work
